TEST REPORT

No. : GZMR240802334701

Sample Name : M8 4P MALE // PNL MOUNT //SC // SHORT CONTACTS
Model No. : 855-004-103R0S4 / IP69K box
Material No. : 855-004-103R0S4 / IP69K box
Manufacturer : NORCOMP

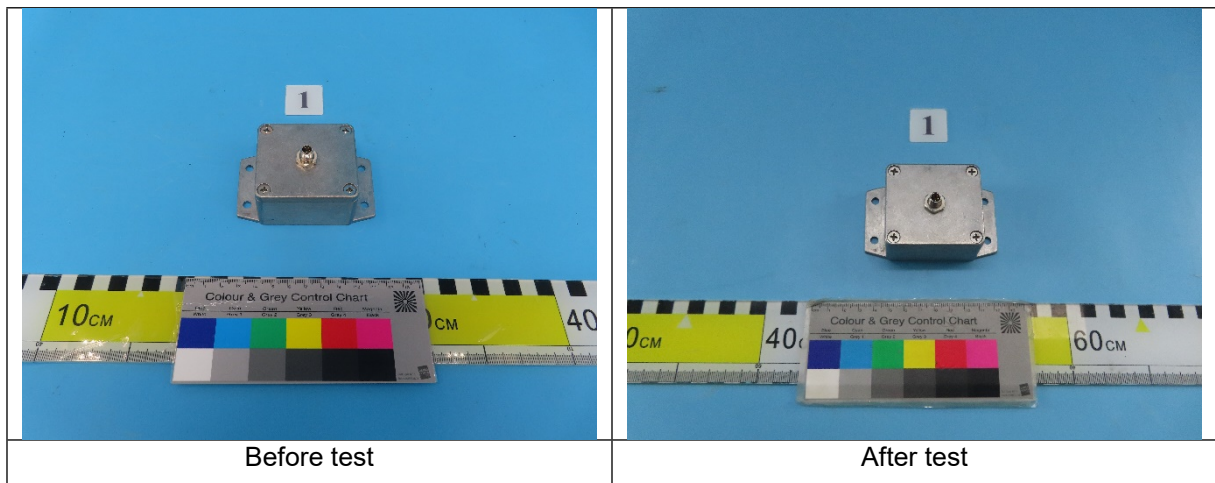
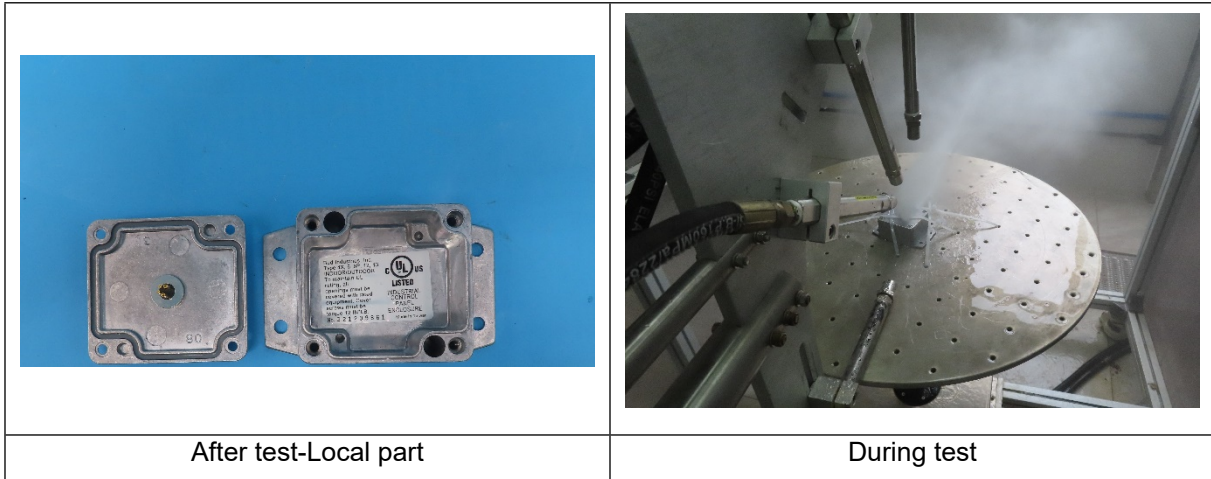
Test Photo:

1. Test Item: IPX9K

Test Condition

Turntable speed: (5±1) r/min

Water flow: (14~16) l/min

Water pressure: approx. (8000~10000) kPa

Water temperature: (80±5) °C

Test position: 0°, 30°, 60°, 90°

Test distance from jet to Sample: (100~150) mm

Test duration: 30 s/position

Specimen No.	Result	Client's requirement	Conclusion
A-1	No visual ingress of water	No visual ingress of water	Pass

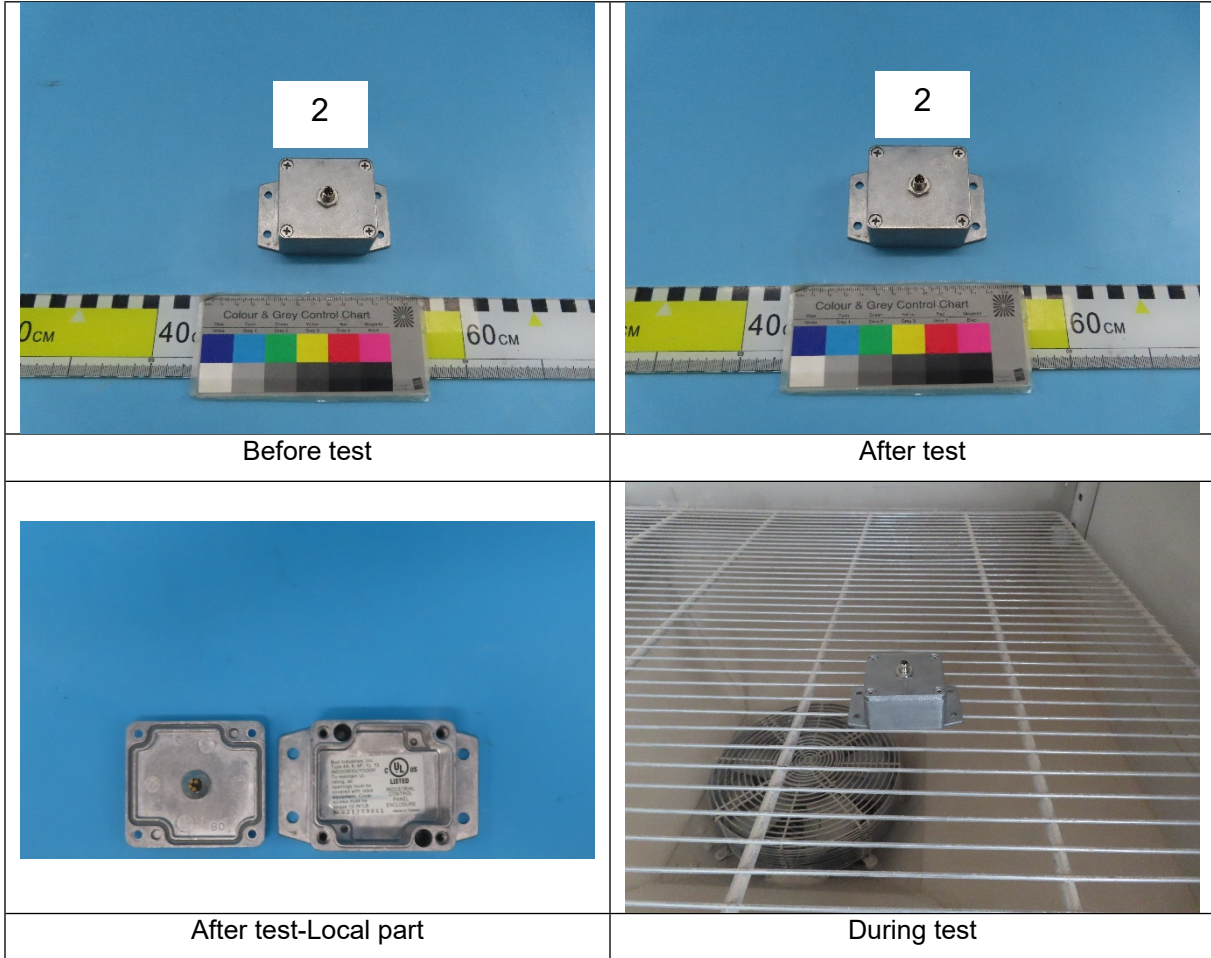
Test Photo:

2.Test Item: IP6KX

Test Condition:

Test Dust: Arizona Dust (A2)

Dust Concentration: 2 kg/m³ chamber volume and be kept in suspension during the test

Operation Method: 6 s movement of the air/dust mixture, 15 minutes break

Test Cycle: 20 cycles

Specimen No.	Result	Client's requirement	Conclusion
A-2	No visual ingress of dust	No visual ingress of dust	Pass
